NEEDS ASSESSMENT STUDY:

**RUDGEAR ESTATES
SWIMMING POOL**

Walnut Creek
California

Aquatic Design Group, Inc.
2226 Faraday Avenue
Carlsbad, CA 92008
760.438.8400
www.aquaticdesigngroup.com

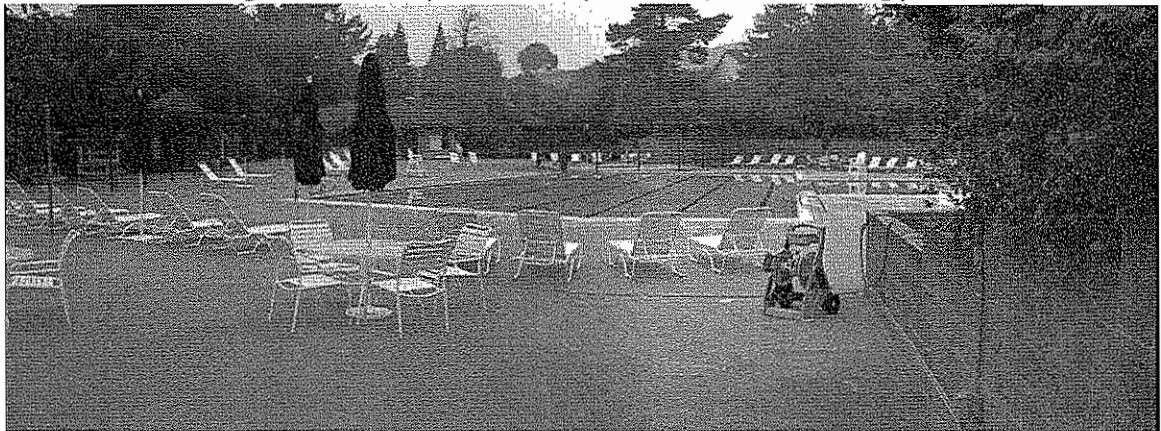
EXHIBIT 2: POOL LAYOUT

The Rudgear Estates Homeowners Association Pool facility consists of a swimming pool, wading pool bath/mechanical building, storage/concession building, and outdoor recreation areas. The assumptions and conclusions in this report are based solely on the visual evidence found during our site visit and comments provided by the staff. Neither construction plans nor as-built plans were available for our review in preparation of this report. No destructive testing was conducted to determine structural viability of the pools or other structures.

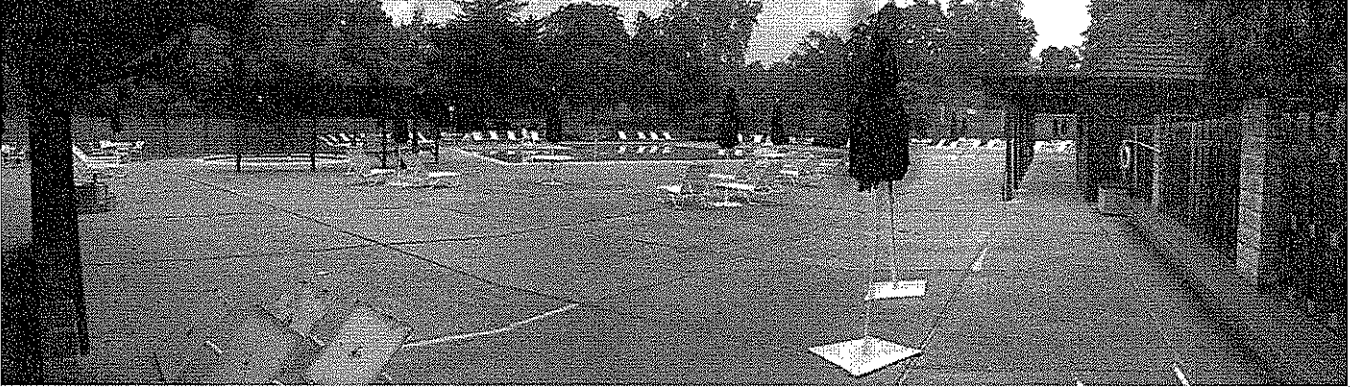
EXHIBIT 3: SWIMMING POOL LAYOUT

The swimming pool is a "T" shaped pool that has a swim area that is 75-feet long and 42-feet wide. This lap area features 6 marked lanes for lap swim and competitive use. These lap lanes have a water depth of 3'-6" at both ends and 5'-0" in the middle. The "T" portion of the pool has a diving area that supports a 24" above water diving board. The pool has water depths ranging from 3'-6" to 8'-6". The swimming pool has a plaster and tile finish that is delaminating. The swimming pool has six sets of recessed steps and grab rails as points of egress from the pool. The pool has eight surface skimmers for surface water collection. The pool also has two main drains for bottom water collection. The drains are marked with a VGB (Virginia Graemme Baker Pool and Spa Safety Act) decal as a tested and compliant VGB drain fitting. The HOA members report that the VGB drains are compliant with California AB1020. The pool deck has a broom finish natural color concrete. The original fixed lifeguard chairs have been removed and a moveable lifeguard chair is now used. The staff reports that they are not aware of any pool water leaks that might bring suspicion to the viability of the pool shell or structure.

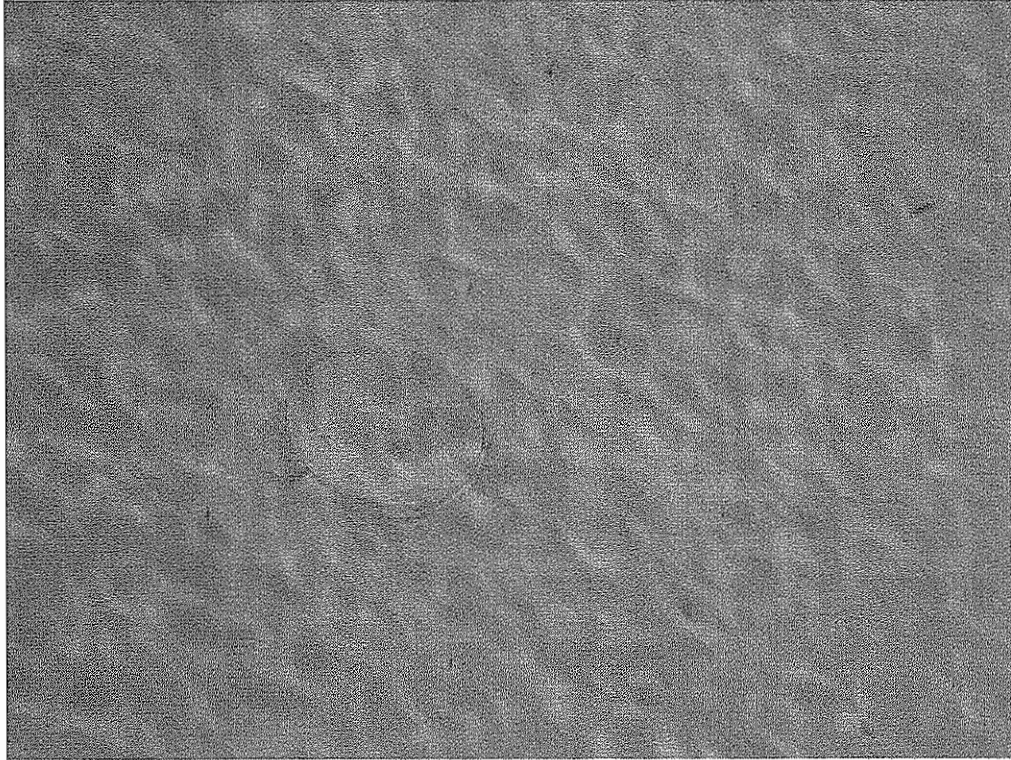
EXHIBIT 5: POOL FINISH FAILING

I.1 Pool Plaster Finish:

The swimming pool plaster finish is delaminating leaving rough edges and voids that can create hazards in violation of Title 24, Chapter 31B:

3106B.2 Finish. The finished pool shell shall be lined with a smooth waterproof interior finish that will withstand repeated brushing, scrubbing, and cleaning procedures. The interior pool finish shall completely line the pool to the tile lines, coping, or cantilevered deck.

The swimming pool plaster and tile finish should be replaced. To ensure that the new plaster finish will have a long life equivalent to a new pool finish it is important that the contractor remove all of the existing plaster or previous finishes to bare gunite so that the new plaster has a rough porous surface to bond to. The following estimate includes removal of all existing previous pool finishes to bare concrete and the installation of a new plaster and tile finish for the swimming pool. The wading pool finish appears to be satisfactory and is not included in the following estimate as part of the renovation work. (SEE EXHIBIT 5)

(Estimated Cost \$85,000.00)

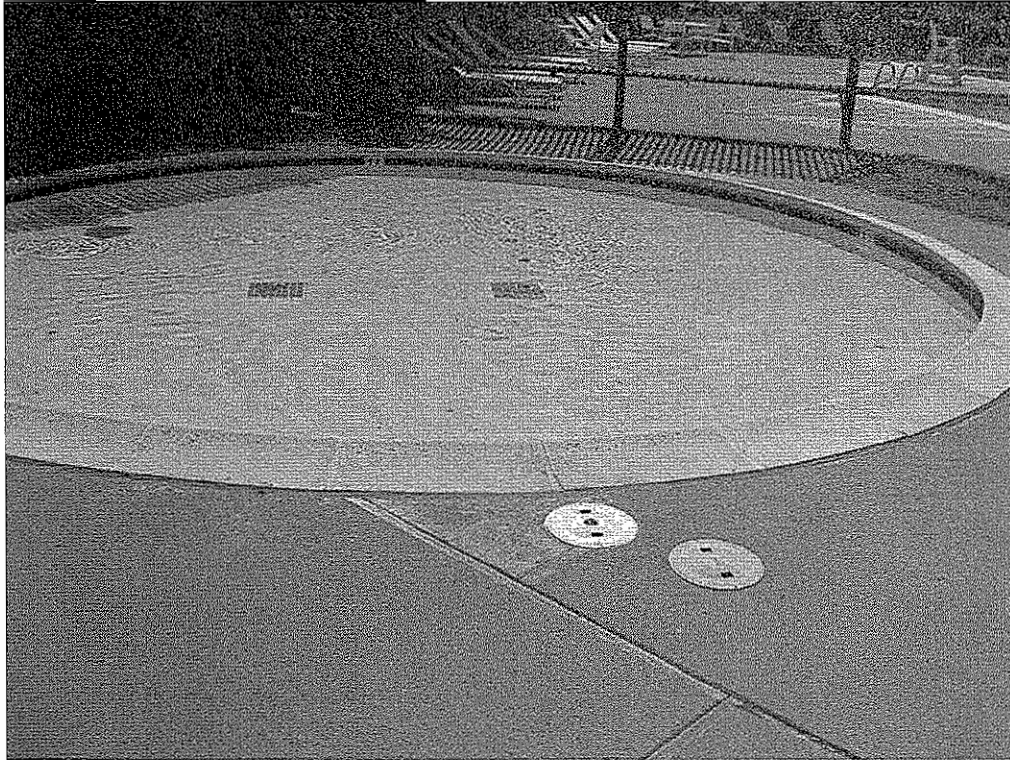
EXHIBIT 6: NO DECK DEPTH MARKERS

The wading pool and portions of the swimming pool lack deck depth markings and no-running or no-diving safety markings in violation of Title 24, Chapter 31B:

Additional deck markers should be installed to comply with code. (SEE EXHIBIT 6)

(Estimated Cost \$5,000.00)

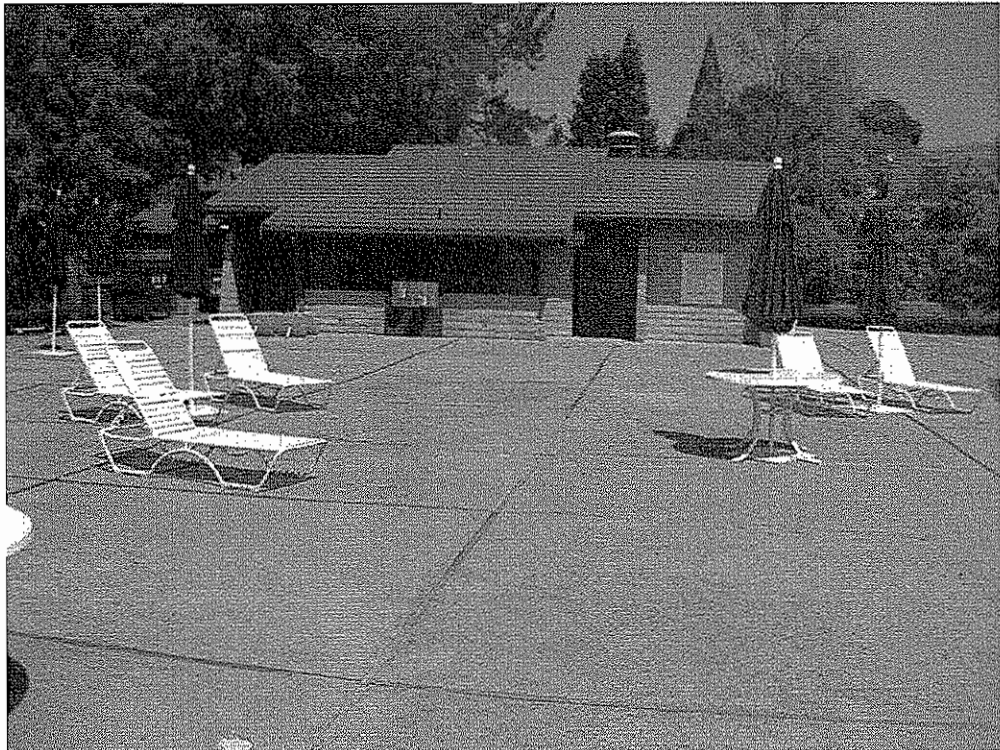
EXHIBIT 7: BATHHOUSE

The swimming pool lacks minimum number of bathroom fixtures as required by code. The bathrooms are constructed with square wall to floor transitions in violation of title 24, Chapter 31B:

The existing bathrooms are constructed with a concrete floor and concrete masonry block walls. This construction does not have a coved transition as required by code. Both the floor cove and the number of fixtures are currently operating on a grandfathered approval from the county health department. Baring some unforeseen event it is likely that the health department is likely to allow the facility to continue to operate with these conditions. If a major renovation is conducted, or if the swimming pool is expanded in size then it is likely that the health department will require that this space be brought into compliance with code. In addition the bathrooms do not provide any ADA accessible facilities. To provide the minimum number of fixtures for the current amount of pool water surface area or to make the bathrooms ADA compliant each bathroom area will require a minimum square footage of approximately 235 square feet. This assumes one ADA complaint toilet and shower in each room. The remaining

(Renovated Bathhouse Estimated Cost \$100,000.00)

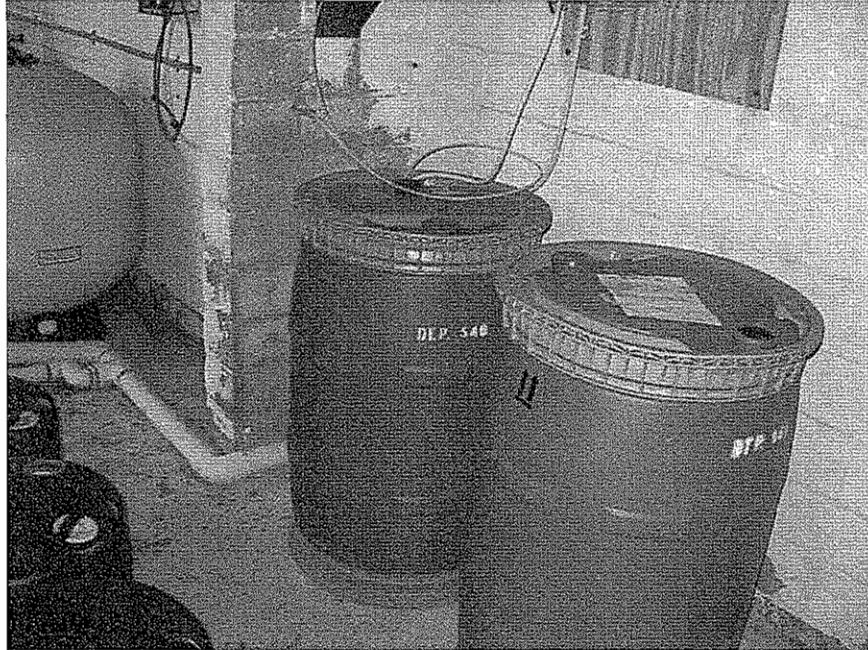
EXHIBIT 9: CHEMICAL STORAGE

The swimming pool operates with liquid chlorine (12% sodium hypochlorite) and muriatic acid (30% hydrochloric acid). These chemicals are stored in vendor provided drums in a room connected and open to the pool mechanical equipment. The pool electrical panels are located in the chemical storage area. The chlorine and acid are stored in the same place without any means of separating the two chemicals. There are several concerns about this method of storage of the chemicals. The first is that lack of separation of the chlorine and acid. If the tanks were to leak or if the two chemicals were allowed to combine they can form poisonous gases such as chlorine gas or mustard gas. Secondly the chemicals, especially the muriatic acid, emit fumes while stored in the drums. The muriatic acid fumes will mix with the humidity in the room to form hydrochloric acid condensate. There is evidence of this occurrence by the rust and corrosion on the electrical panels and other metal components. Such exposure can shorten the life of the metallic components or equipment in the mechanical space. There are several ways this condition can be improved. The first is to create separate chemical storage spaces to separate the chemicals from the mechanical and electrical equipment. This separate space can be outdoor fenced in enclosures or new building spaces. The second option is to eliminate the muriatic acid and switch to carbon dioxide (CO₂) which does not emit corrosive fumes. A third option is to store the acid in a tank connected to a vapor recovery system to prevent the off-gassing of corrosive fumes into the mechanical room. In addition the chemical tanks for both the chlorine and the acid can be double contained to prevent the inadvertent mixing of the two chemicals. A discussion with members and operators will need to be conducted to determine which option is best for the facility. (SEE EXHIBIT 9)

(Option 2 Estimated Cost \$14,000.00)

(Option 3 Estimated Cost \$4,000.00)

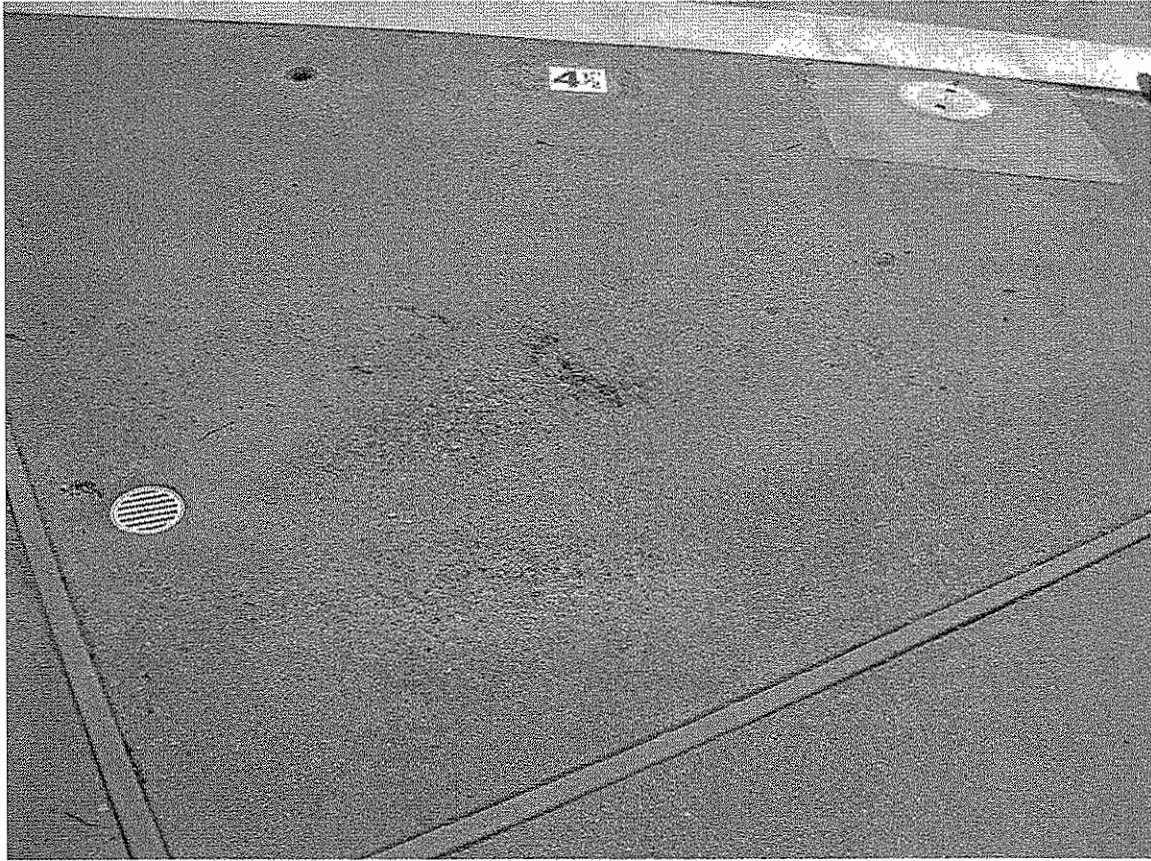
EXHIBIT 10: EXISTING POOL DECK

The existing concrete pool decking is deteriorating. There are portions of the deck that are heaving creating potential trip and fall hazards. Some of the redwood expansion joint filers have been replaced around the pool deck. There are also areas of the pool deck that are spalling, which can create porous surfaces that can trap and collect water allowing mold or biofilms to form, which can be tracked into the pool water and swallowed by swimmers. The condition of the deck has not yet deteriorated to the point that the health department has deemed it a health or safety risk, but it will only continue to worsen. The question is the time it will take until the deck must be replaced. As noted previously in this study, to accomplish some renovations to the pool a portion if not all of the deck will have to be removed to provide access to underground plumbing. The use of a topping material to refinish the existing pool deck surface is not a viable option. First a topping coat will not resolve the vertical differential spaces. Secondly, topping coats are typically a temporary fix with an expected life span of between 2-5 years. The existing pool deck is slightly larger than 21,000 square feet. This is an extremely large volume of concrete paved area. In lieu of replacement of all of the concrete some of the areas can be renovated with less expensive materials including grass. Additional investigation will be required to determine what other viable options could be considered. The following is an estimate to remove and replace the entire pool deck and reconfigure the deck drainage system. It is possible to remove and replace a portion of the pool deck or to replace a portion of the pool deck with a new material other than concrete. The detailed evaluation of these options are outside the scope of this report. (SEE EXHIBIT 10)

(Estimated Cost \$360,000.00)

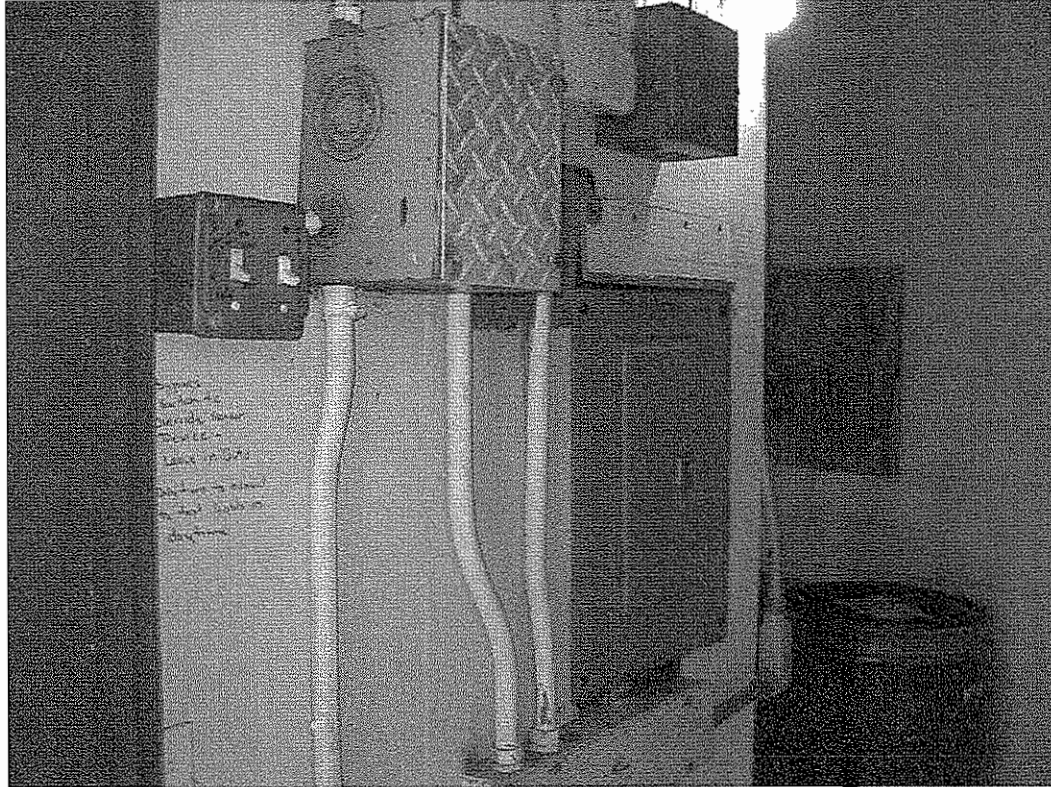
EXHIBIT 11: EXISTING ELECTRICAL

There are reports of electrical breakers tripping during swim meets and member parties. The electrical panels appear to be the original equipment. The electrical service has recently been upgraded at the BBQ area, though it is not known at this time if this is adequate to meet all user group needs. As noted previously much of this equipment in the chemical storage area is corroded due to time and exposure to pool chemicals. The following is an estimate to upgrade the existing electrical equipment in its existing locations. (SEE EXHIBIT 11)

(Estimated Cost \$18,000.00)

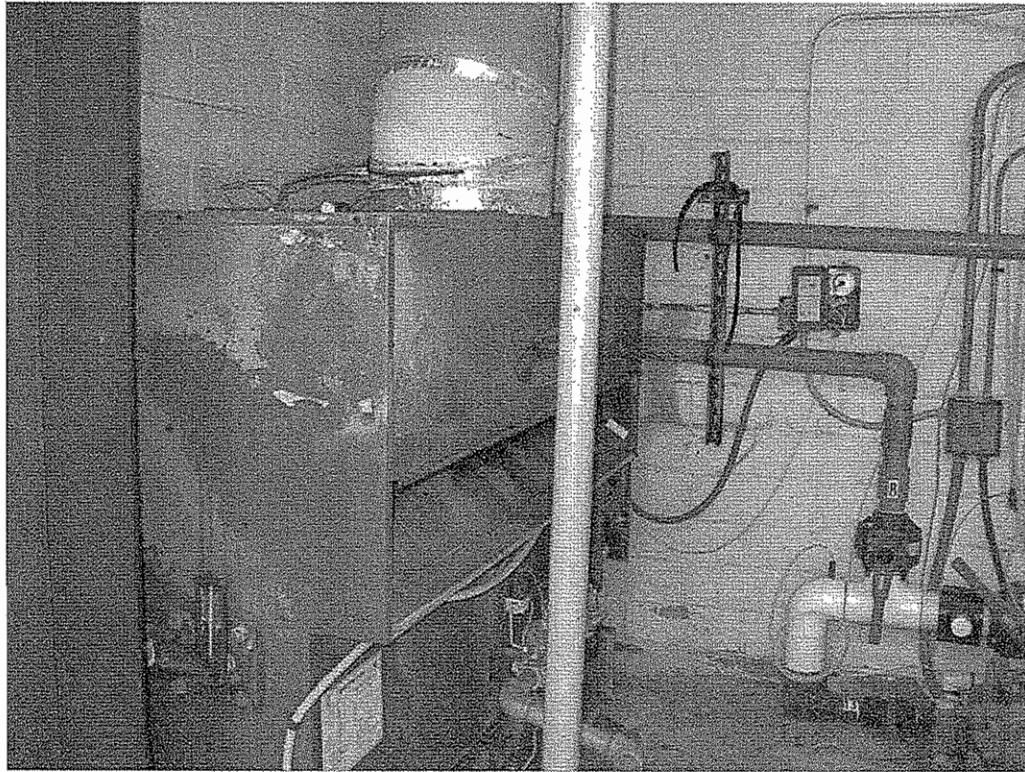
EXHIBIT 12: EXISTING POOL HEATER

The swimming pool heater appears to be original equipment. The existing heater is a gas fired atmospheric heater with 1,200,000 BTU input. The heater label indicates that this heater is 81% thermal efficient. This heater shows signs of wear and corrosion due to time and exposure to pool chemicals. The current industry standard for pool heaters is a fan assisted heater that is a minimum of 89% thermal efficiency. These new higher efficient heaters will also comply with the Air Quality Control Board's requirements for a low polluting low NOx output, which the existing does not comply with. If pool covers are used every night and with the heating season being from May 1st to September 30th the total heating cost for the swimming pool is estimated at \$10,000.00 per year. This is assuming an average cost of \$1.25 per therm for natural gas. The increase in thermal efficiency of a new heater can result in an approximate

\$1,000.00 saving per year in gas costs. The following estimates assumes that a new (smaller vent stack is installed at the same time. (SEE EXHIBIT 12)

(Estimated Cost \$17,000.00)

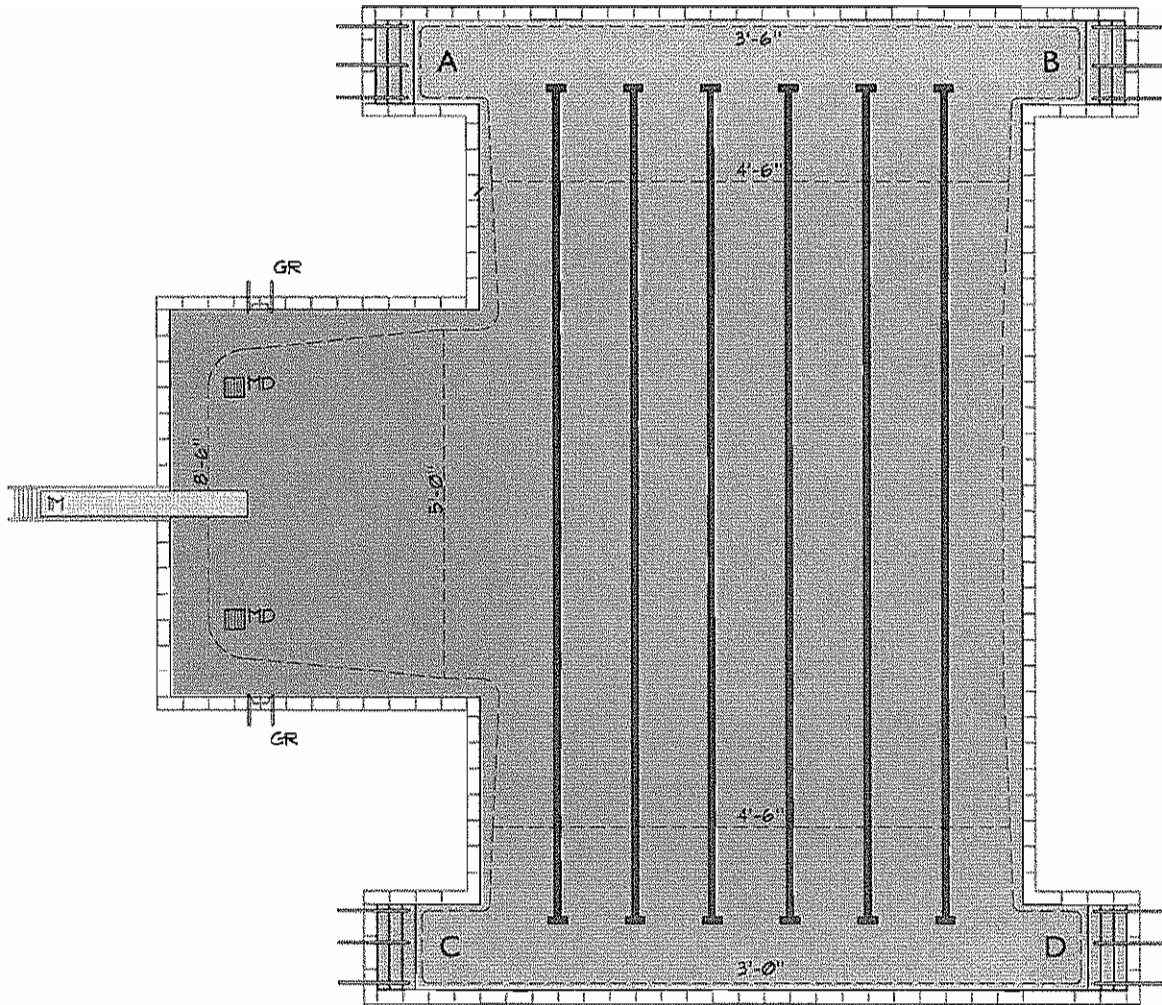
EXHIBIT 13: SWIMMING POOL WALK-OUT STAIRS

The swimming pool currently has six sets of recessed steps with grab rails as means of entering or exiting the swimming pool. These recessed steps require that a bather climb a vertical wall using these steps. This can be difficult or impossible for certain members. A portable fiberglass stair case is used to drop into the pool to allow such patrons to use the swimming pool. The challenge with these portable stairs is that the county health department is concerned that they may pose a life and safety risk in the pool. As such the health department will only allow the portable stairs to be used when the water fitness group is using the pool. When this group is done the portable stairs must be removed from the pool and stored on the deck. Such frequent movement shortens the life of the fiberglass stairs as they get knocked around. Secondly these stairs are heavy and may result in a workman's compensation claim if a lifeguard is injured moving these around. A permanent set of walk-out stairs can be added to the pool. These stairs would be constructed of concrete and plaster the same as the pool itself. This work can be done at the same time the pool plaster is being replaced to provide access to the pool concrete shell. These stairs are shown in exhibit I3, with a set of handrails that serves as a secondary means of ADA access into the pool and a third handrail for other patrons. This stair area can also be used for small children for recreation or swim lessons. The following illustration of the swimming pool in exhibit I3, shows four potential locations "A thru D" that such a set of stairs can be added. The members could choose to add one to four of these stairs as they see fit. The following cost estimate is for each stair added to the pool. (See Exhibit I3)

(Estimated Cost \$50,000.00)

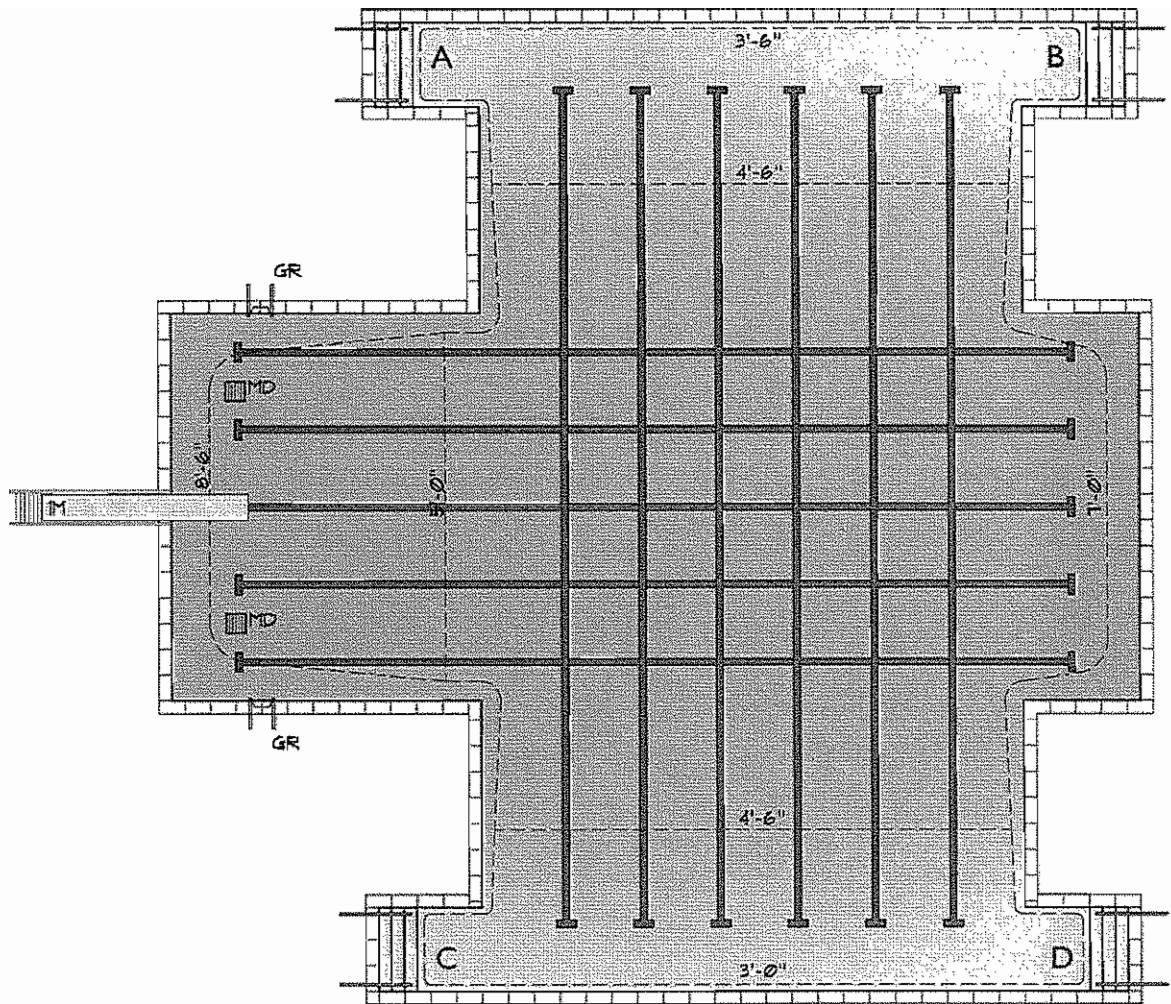
EXHIBIT 14: RACING DEPTH REMODEL

The National Swimming Pool Foundation states in their Aquatic Safety Compendium that spinal injuries from diving accidents in a swimming pool are non-existent when the water is 7' deep or deeper. California Health Code Title 24 Chapter 31B requires the installation of no diving signs where the water depth is less than 6'. Based upon this data the racing platforms at the Rudgear swimming pool should be discontinued in the 3'-6" water depth areas. The "T" portion of the pool has a water depth of 8'-6", which could support racing platforms, but the pool length is too short in this direction to be used for competition. The pool can continue to support swim meets with swimmers starting within the pool or the pool can be reconfigured to provide safe racing platform dives into the pool. Since a gunite swimming pool uses the adjacent soil as a form the pool floor cannot be removed to make the pool deeper without demolishing the pool walls as well, which would result in the complete demolition of the existing pool. Since there is no practical way to deepen the swim lane areas to support this program, alternative methods will have to be considered. The following illustration shows a possible pool renovation that could support a maximum of 5 swim lanes for competitive use without demolishing the entire pool. This option shows both the options for the 25-yard lanes in the same direction as the diving board. The water depth at the opposing end of the pool from the diving board can be 7' deep to meet all standards for racing platform diving. This option also shows the four potential sites for the walk-out stairs as well. This pool extension and stairs would be constructed of concrete and plaster the same as the pool itself. This work can be done at the same time the pool plaster is being replaced to provide access to the pool concrete shell. This scope will also require the removal of a portion of the pool deck at a minimum. This option will also create more pool water surface area which will require the renovation of the bathrooms to provide the minimum bathroom fixture count as well. The following cost estimate assumes that the pool is being replastered at the same time under a separate cost estimate. This estimate does not include the removal of the pool deck or remodel of the bathrooms. (SEE EXHIBIT 14)

(Estimated Cost \$125,000.00)

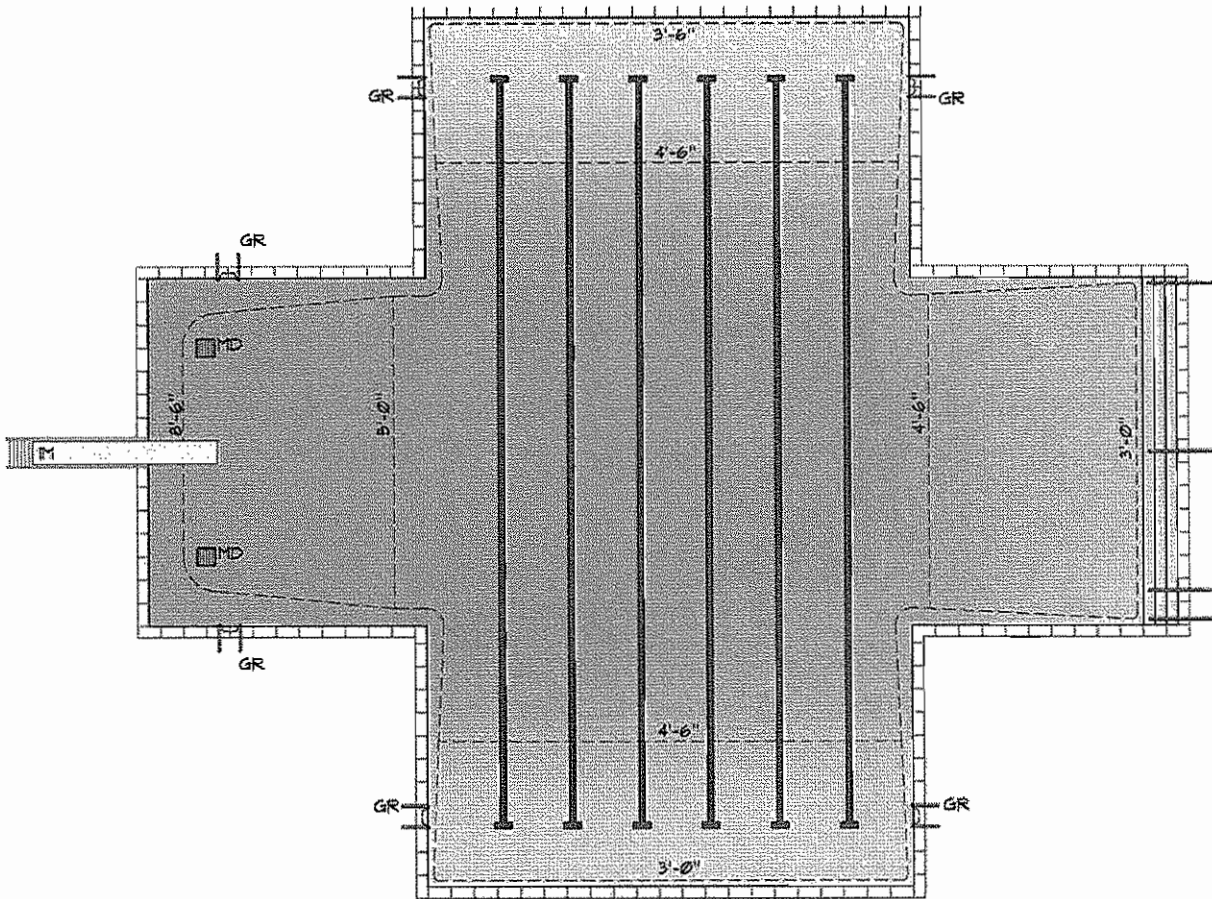
EXHIBIT 15: PLAY AREA REMODEL

Another option to be considered in the renovation of the swimming pool is to extend the pool on the west side to create a play area for children that would allow lap swimming to occur simultaneously. In this option the pool stairs become a large area at the end of the renovated section. This will eliminate the need for walk-out stairs as previously presented. This option does not solve the problem of deeper water for competitive swimming as noted in section 3.3 above. The following cost estimate assumes that the pool is being replastered at the same time under a separate cost estimate. This estimate does not include the removal of the pool deck or remodel of the bathrooms. The chart below indicates the minimum bathroom fixtures required for this 4,590 square foot of pool water option. (SEE EXHIBIT 15)

(Estimated Cost \$130,000.00)
